Park East Square HOA
Boulder, CO

Report #: 31350-1
Beginning: January 1, 2025
Expires: December 31, 2025

RESERVE STUDY
Update "With-Site-Visit"

March 28, 2025

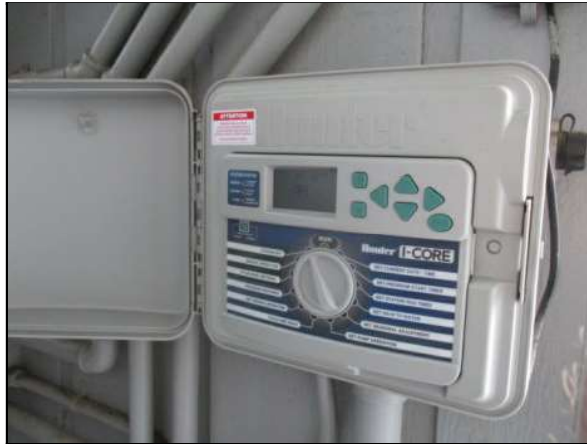
Comments: Includes (12) Hunter I-Core clocks. Minimal or no subjective/aesthetic value for this component. Useful life is based primarily on normal expectations for service/performance life in this location. Unless otherwise noted, remaining useful life expectancy is based primarily on original installation or last replacement/purchase date, our experience with similar systems/components, and assuming normal amount of usage and good preventive maintenance. Irrigation controllers should have a relatively long life expectancy under normal circumstances. Replacement is often required due to lack of available replacement parts, lightning strikes, etc. as opposed to complete failure of existing equipment. Exposure to the elements can affect overall life expectancy, and controllers should be located in protected areas or within protective enclosures whenever possible. When evaluating replacement options, the client should consider replacement with 'smart' models (i.e. respond to projected weather data) to minimize unnecessary water usage. Payback period for efficient controllers that minimize water use is typically very short
