**Background:** After many years of minimal repairs, in order to protect our owner's assets, the HOA has now spent 8+ years repairing the siding and trim on approximately 6 buildings per year, using two different companies. This document aims to consolidate the knowledge and lessons learned and create some "performance specifications" or requirements for future work.

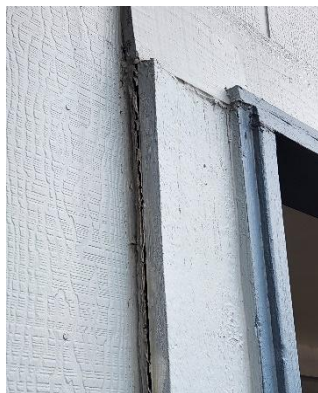
- The architectural detailing with trim boards around the base of the building, around windows and carport openings created innumerable ledges on which moisture accumulates and eventually makes its way through the paint and caulk to sometimes rot what's underneath.
- The siding and trim on buildings with roof overhangs have fared considerably better over the years compared to facades without roof overhangs.
- The extent of repairs needed often depends on the orientation of the building - which side faces the prevailing winter weather or the southern sun.
- The original design of the D unit balcony railing creates a perfect place for wasps to nest.
- The original design of the D unit plumbing in a chase and soffit in the carport creates opportunity for frozen pipes in the winter.

*Old carport trim detail*

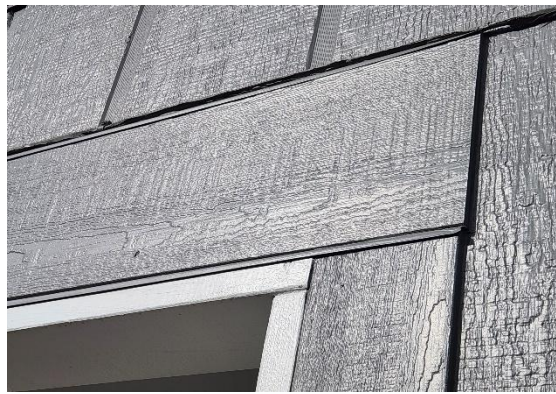
*New carport opening detail without ledges and with flashing to prevent moisture intrusion*

- New carport opening trim boards (2 x 6’s) are re-installed to be flush with the siding and trim, and the trim is flashed to prevent future moisture intrusion. Metal L-brackets (often salvaged from the old trim boards) are attached to the 2 x 6’s at car bumper height for reinforcement.

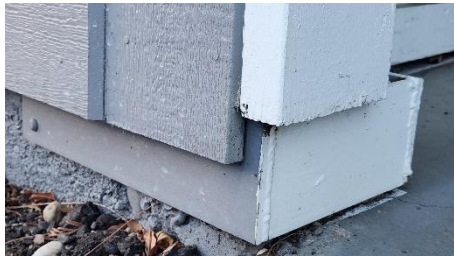
*Repaired concrete piers*

- The concrete pier supports with re-bar centers and support plates for the posts are often somewhat crumbled around the outside edges, but are not usually structurally compromised. A metal form should be created to surround the concrete pier and new concrete poured within to provide a flat stable surface to support the king studs.

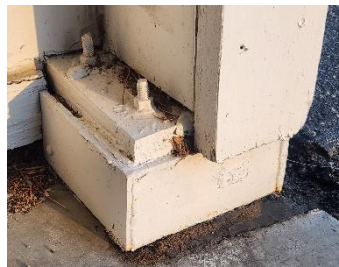
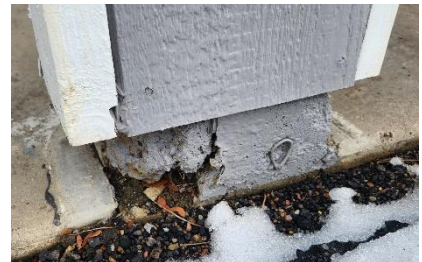
*Crumbled concrete pier*

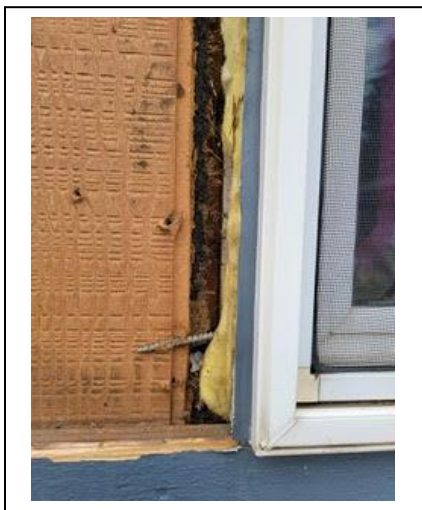
*Screw between  
siding and trim*

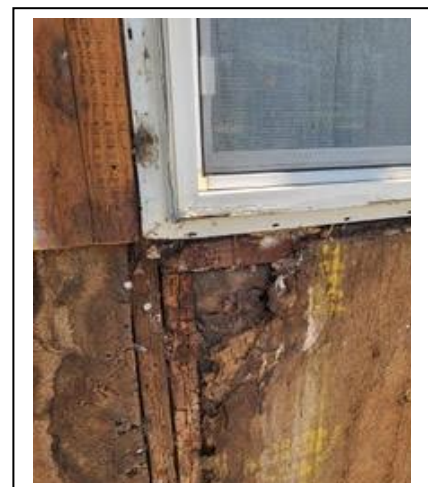
*Rotten siding  
underneath trim  
below window*

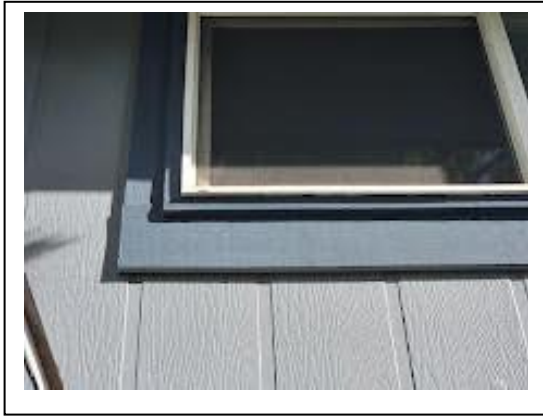
*Trim not removed, window not inserted far enough into wall opening, so extra trim added.*

- Exterior window trim must be removed, and interior drywall and sills must be cut back so the new window can be fully inserted into the opening, ensuring that the screws go into the studs. A small strip of siding around the window opening must be removed to accommodate the nailing flange, which is then taped and caulked before the exterior trim is replaced. If the new construction window does not come with flashing above, then flashing should be added, in addition to flashing above the trim board.

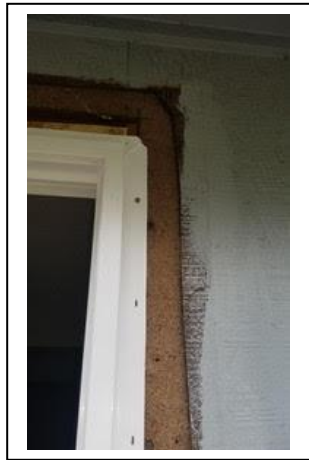
*Window flanges & siding cut back*

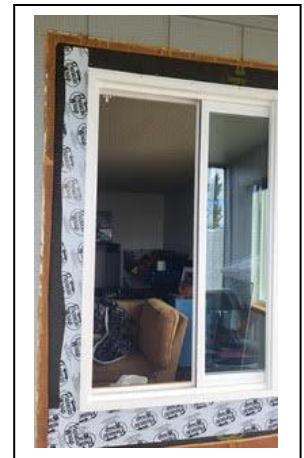
*Flanges caulked & taped*

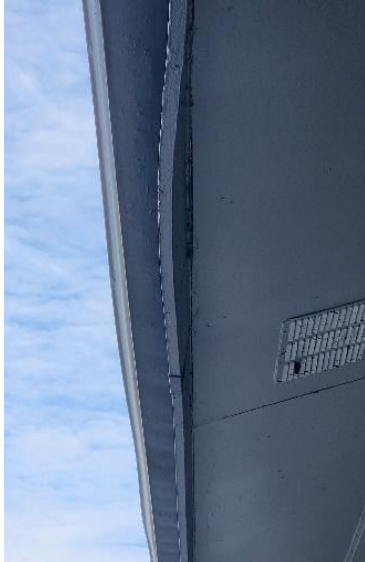
- Fascia boards holding gutters, and trim and siding adjacent to downspouts are checked and replaced as necessary. Non-structural wing walls are repaired, especially at the bottom where they may be rotten. A

*Bowed fascia board*

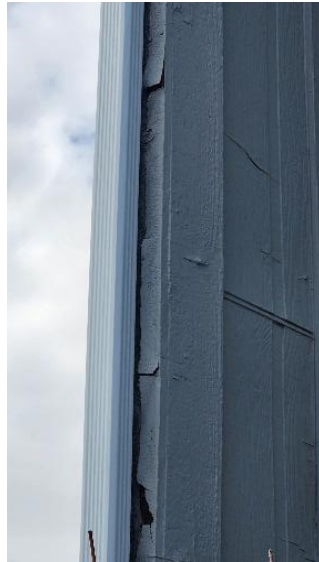
*Trim board under downspout in bad shape – often an indicator that the old downspout split on the back and needs to be replaced*

- Gutters and downspouts are evaluated on all buildings each year and are handled by a separate contractor. For the most part, the old 4 inch steel gutters (that rust and develop holes) are being replaced by 5 inch aluminum gutters, especially on long runs. In addition, the old “spike” hanging system is replaced with a more discreet hanging bracket. Old downspouts with seams on the back (which, when clogged with leaves, freeze and split) are replaced with seamless downspouts.

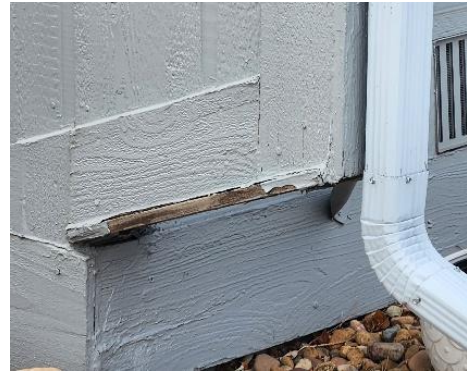
*Wing wall deterioration*

detail that sheds water should be used.

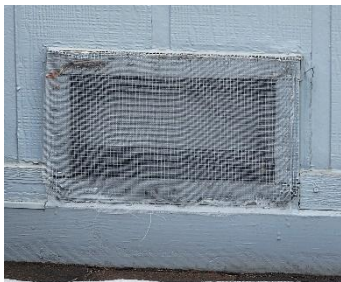
*Inadequate crawl space vents  
In disrepair*

- Crawl space vents are inspected. Ensure that crawl space vents are operable or replaced and replace rotten trim around vents. Inspect dryer vents and alert owner to any problems discovered.

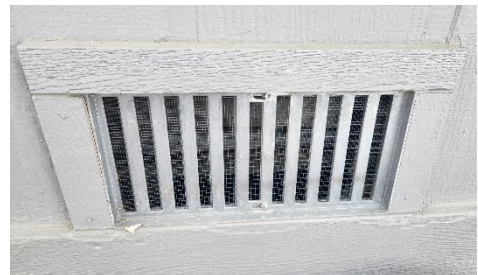
*Proper operable crawl space vent  
that opens and closes*

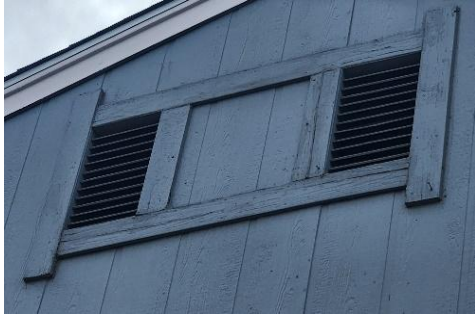
*Attic vents with rotten trim*

- Attic/gable vents and trim are inspected and replaced if needed. Occasionally, the HOA contractor gets a good view of an owner's attic and the HOA notifies the owner of any problems such as fallen drywall in the attic that impedes insulation effectiveness.

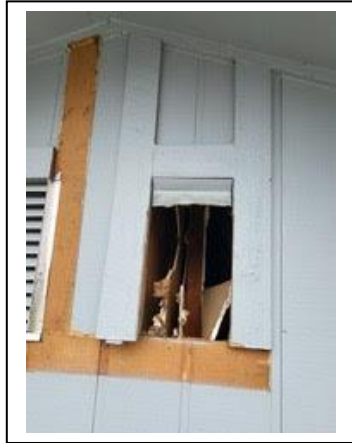
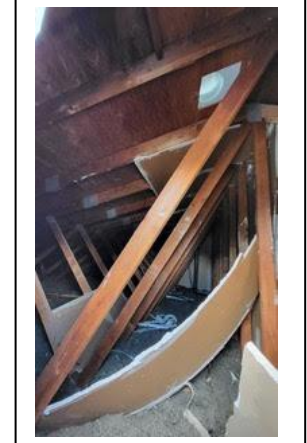
*Fallen drywall in attics, crushing insulation*

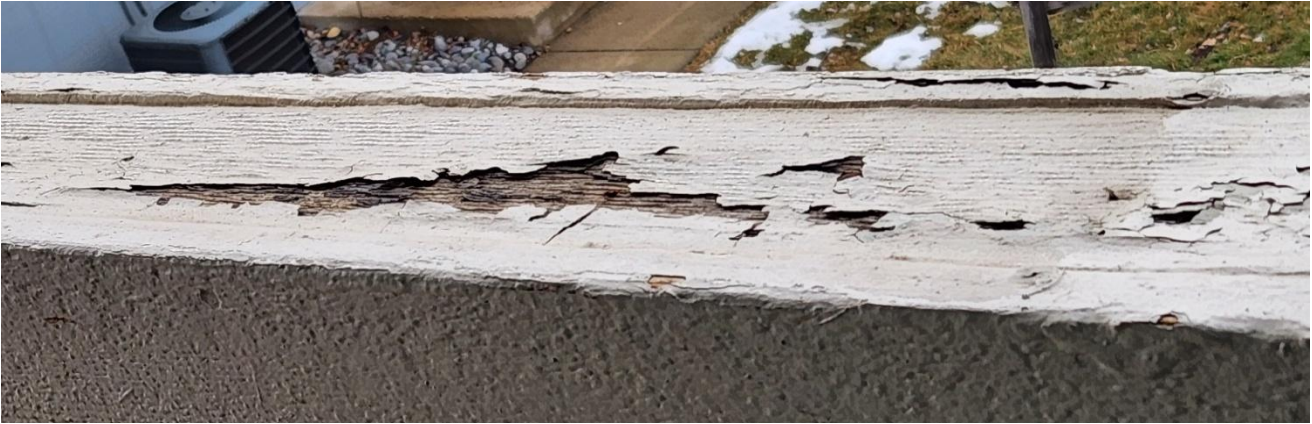
*Original balcony railing top showing dished top which catches rain and promotes rot*

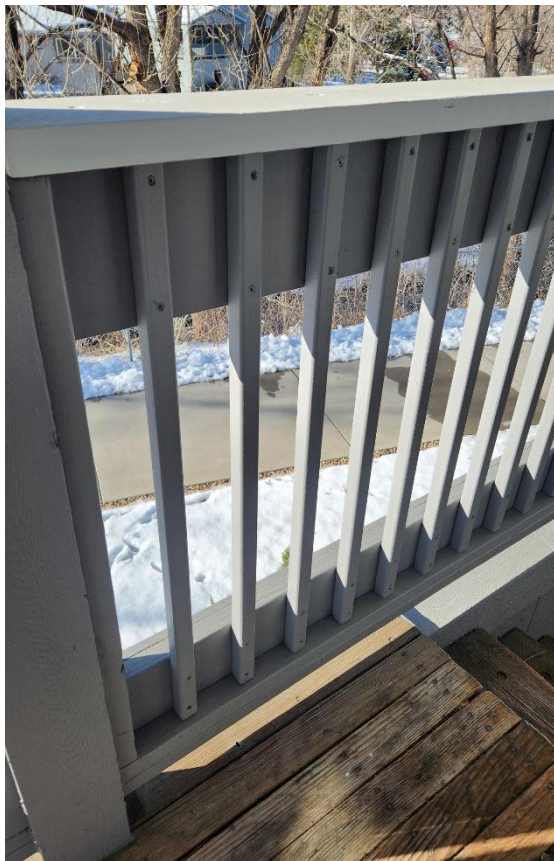
*New railing design which meets code & deters wasps*

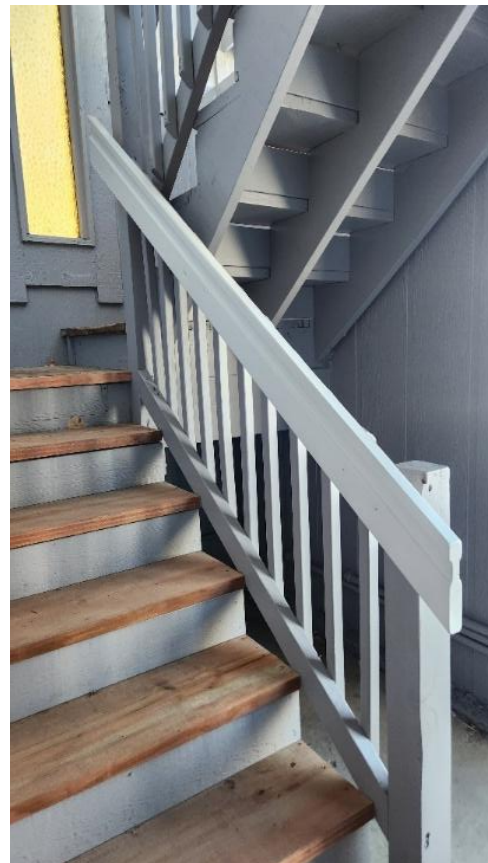
*New stairs with three stringers and closed risers and proper balusters & handrail.*
