Background: After many years of minimal repairs, in order to protect our owner's assets, the HOA has now spent 5+ years repairing the siding and trim on approximately 6 buildings per year, using two different companies. This document aims to consolidate the knowledge and lessons learned and create some "performance specifications" or requirements for future work. In general, the extent of repairs needed depends on the orientation of the building (which side faces the prevailing winter weather or the southern sun) and upon the presence of roof overhangs (or not). Buildings with roof overhangs have fared considerably better over the years.

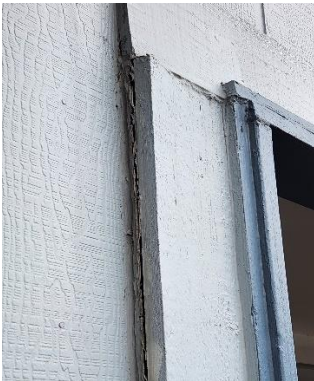
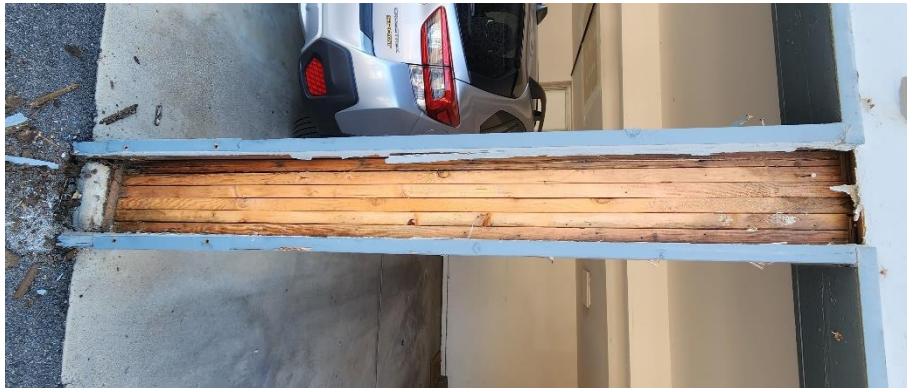
- Repairs are begun by removing the carport trim boards, some of the siding above the carport opening, and on the carport posts to check and ensure the structural integrity of the posts and headers. Sometimes the carport headers are discovered to be rotten due to the original design of the trim boards around the carport openings, the way they poked out and caught and held water/moisture.
- The "celotex" material underneath the siding is often removed because it just holds moisture, staining the posts. The posts consist of king studs in the center which support the second story rim joist, and studs that support the carport headers, which also indirectly support the second story rim joist. As a rule, the posts generally aren't structurally compromised.

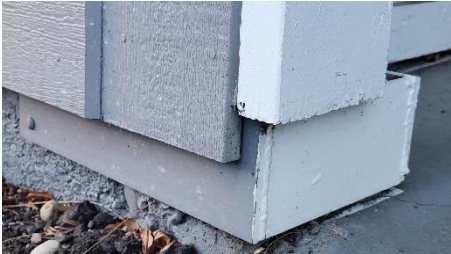
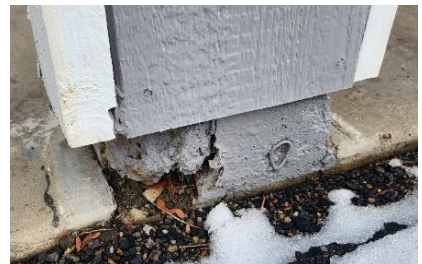
- The concrete pier supports with re-bar centers and support plates for the posts are often somewhat crumbled around the outside edges, but are not structurally compromised. A metal form should be created to surround the concrete pier and new concrete poured within – mostly for cosmetic purposes.

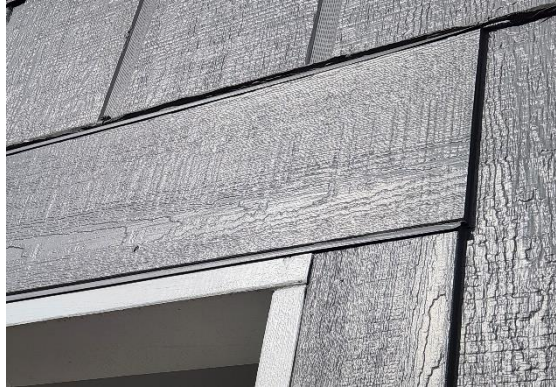
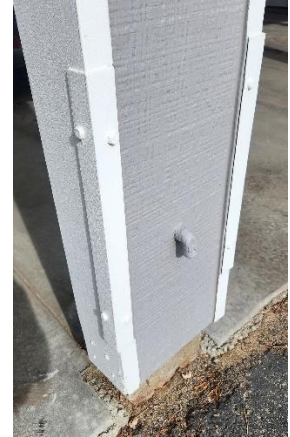
- New carport opening trim boards (2 x 8's) are re-installed to be flush with the siding and trim, and the trim is flashed to prevent future moisture intrusion. Metal L-brackets (often salvaged from the old trim boards) are attached to the 2 x 8's at car bumper height for reinforcement.

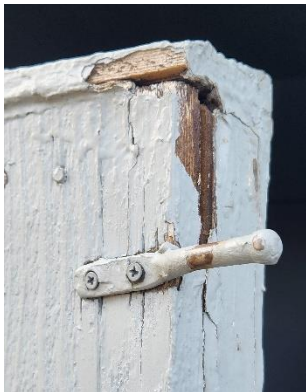
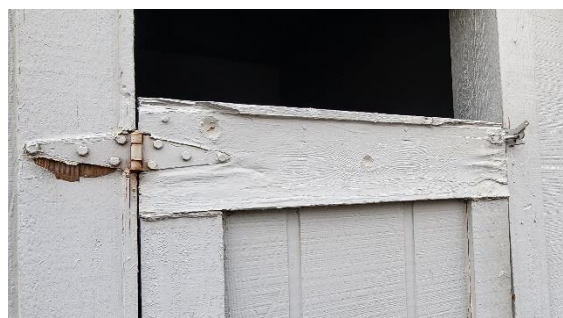
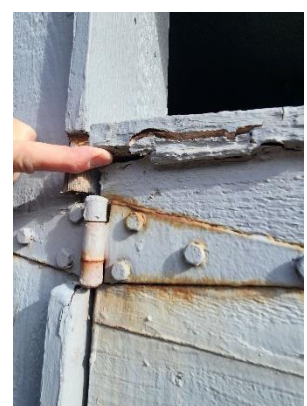
- The trash room door is often re-built, and the trim is re-done and properly flashed. The trash room door swing should be examined and changed if necessary so that it swings closed with the West or NW wind. New substantive hardware is required, secured with through-bolts, not just screws.

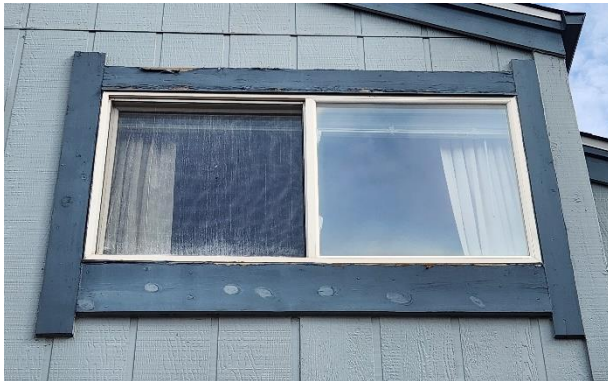
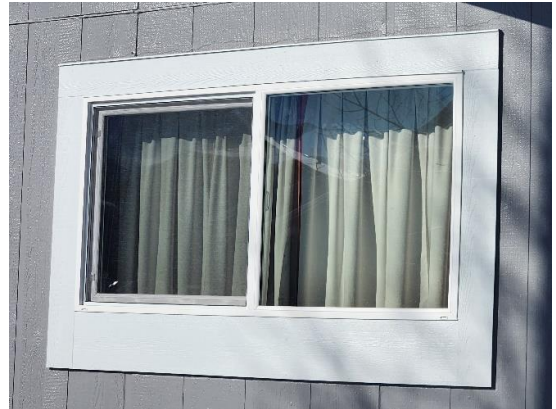
- All windows and trim are checked for moisture intrusion. The original trim designs (with vertical or horizontal “tabs”) should be corrected to deter moisture intrusion, either by replacing the trim if rotten, or removing the water-catching pieces if the trim is in good shape. When trim is replaced, the top piece should extend all the way across (and be flashed), the bottom piece should be just under the window, and the side pieces should extend to the bottom of the bottom trim. See photo with white trim below.
- Owners often desire/choose to replace windows or sliding doors in advance of the building repair effort as a result of the annual architectural survey and subsequent HOA notification that their windows or sliding doors are in disrepair.

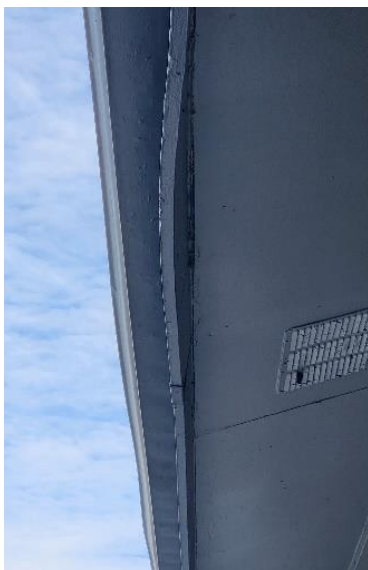
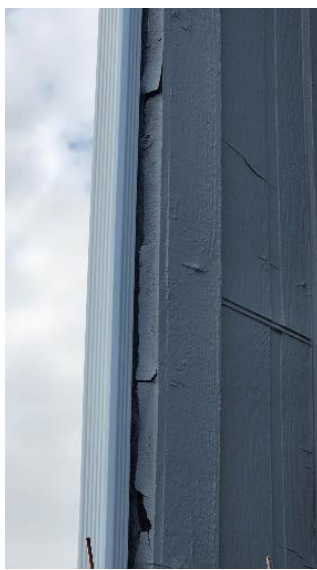
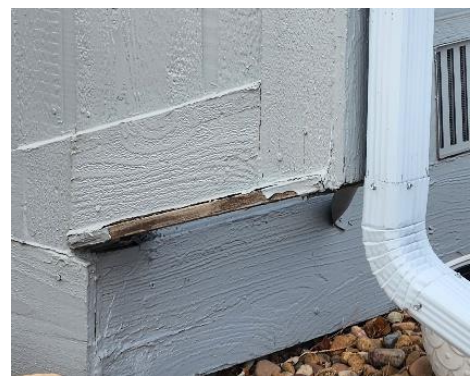
- Fascia boards holding gutters, and trim and siding adjacent to downspouts are checked and replaced as necessary. Non-structural wing walls are repaired, especially at the bottom where they may be rotten. A detail that sheds water should be used.

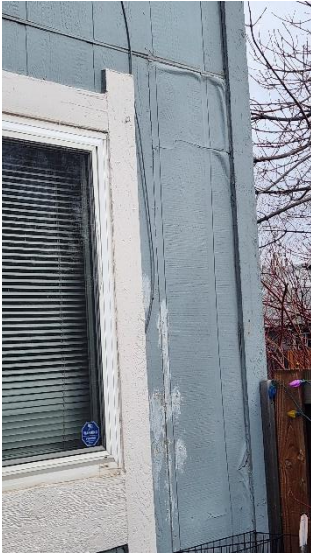
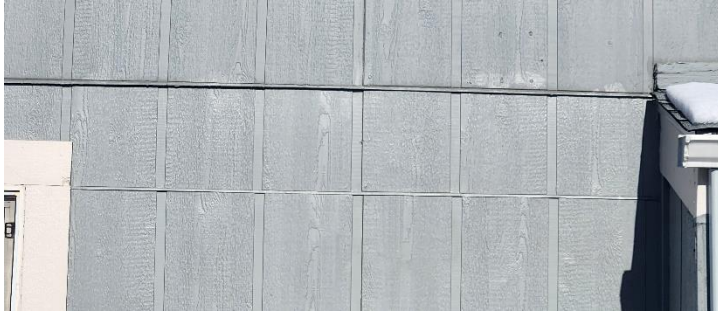
- Buckled or rotten siding due to sun or moisture is replaced. The wall of the B unit next to the A unit is frequently rotten. Unfortunately, the original building used 9 foot sheets of siding, and only 8 foot sheets are now available. So some horizontal joints (see photo below) are now required with proper flashing. OSB and/or Tyvek building wrap is installed under new siding.

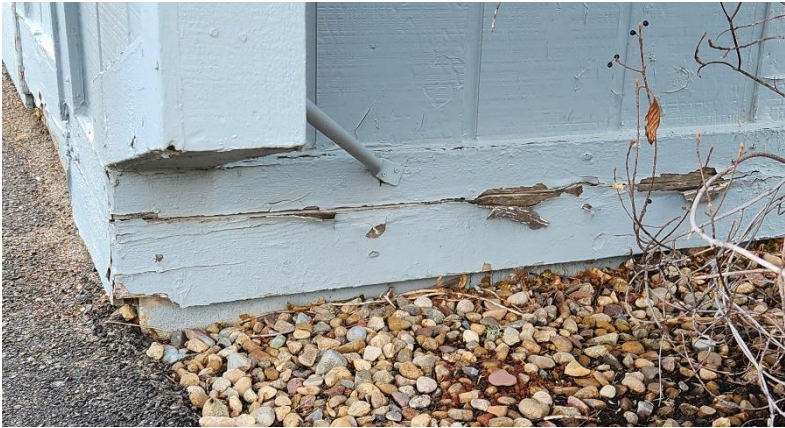
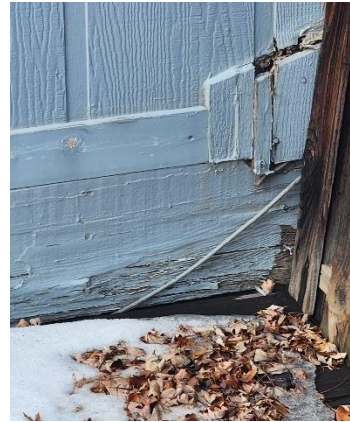
- Trim boards near the ground are often replaced due to being rotten, with Tyvek house wrap underneath. It's important to pull soil and rock away from the trim boards.

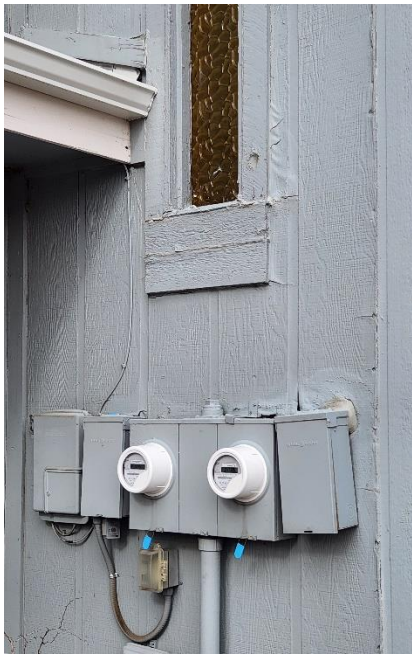
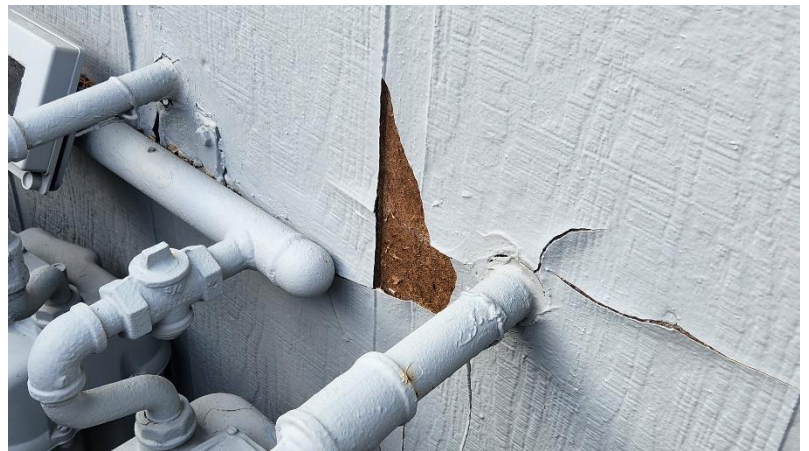
- Meter wall siding exposed to the elements (outside of D unit stairs, and A units) are occasionally rotten. We call Couper Electric to disassemble the electricity for a few hours while we replace the siding and reattach the utility boxes. Gas must be handled with Xcel.

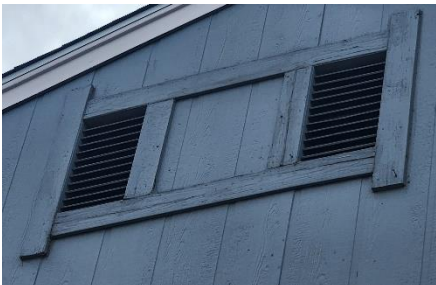
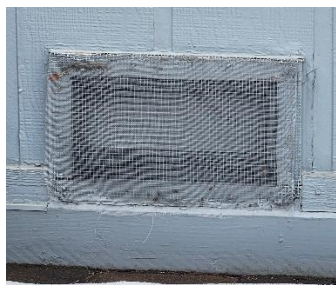
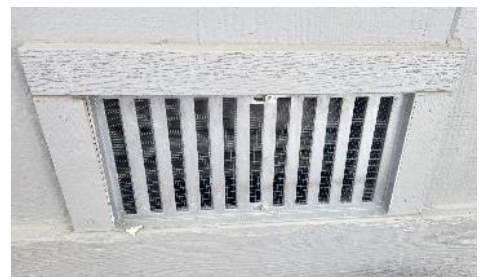
- Attic/gable and crawl space vents are inspected. Ensure that crawl space vents are operable or replaced and replace rotten trim around vents. Inspect dryer vents and alert owner to any problems discovered.

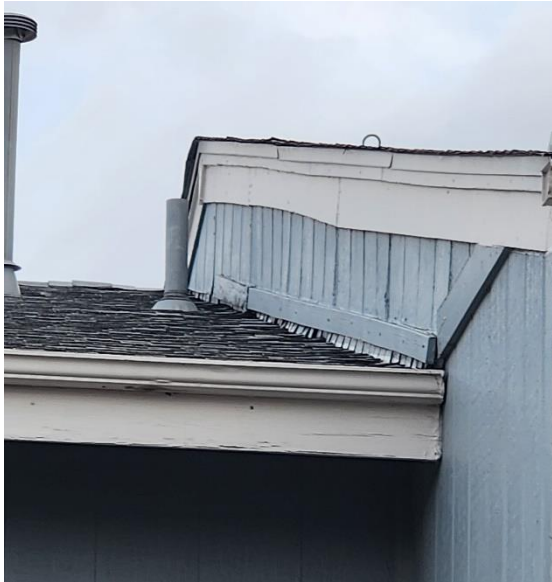
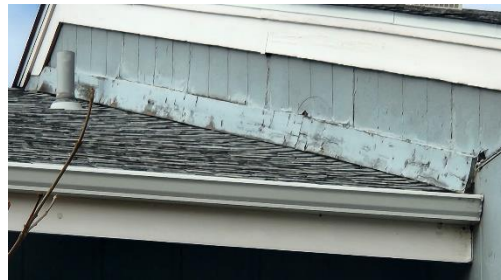
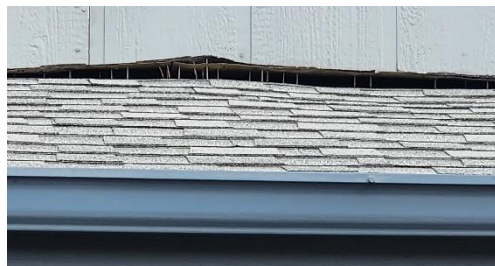
- Inspect roofs for missing shingles, improper step/rake flashing installation, and missing gutter apron or improper pitch of gutters. Where the unit siding abuts adjacent roofs, proper flashing is sometimes needed, and old, ineffective trim boards are removed. Siding should be at least 1.25 inches above the roofline to prevent siding from wicking moisture up the wall. The same holds true for the small decorative roofs over A and C unit front doors and sliding doors.
- Soffits are occasionally repaired where panels have shrunk and cracks have allowed insect intrusions. Soffit vents should be inspected to ensure airflow.

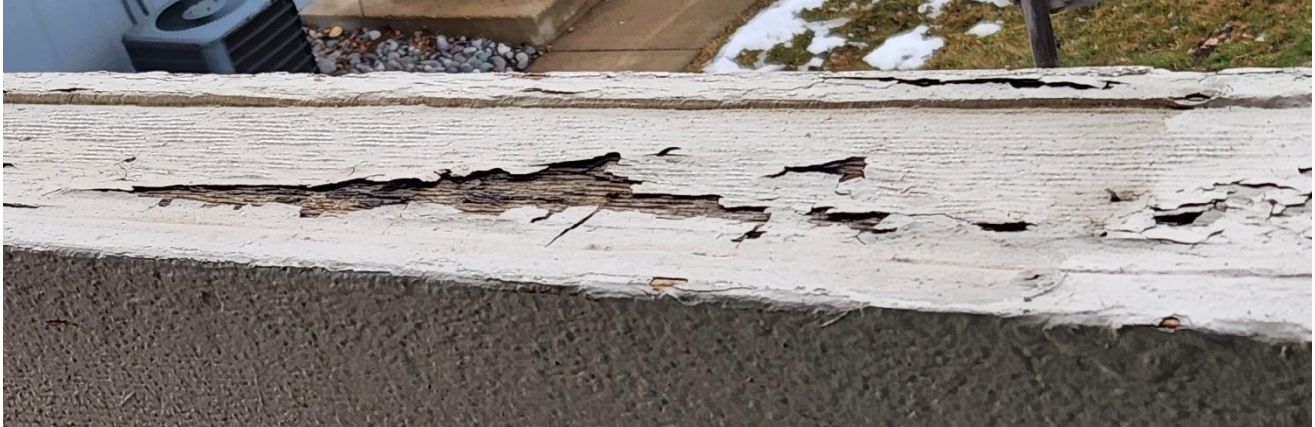
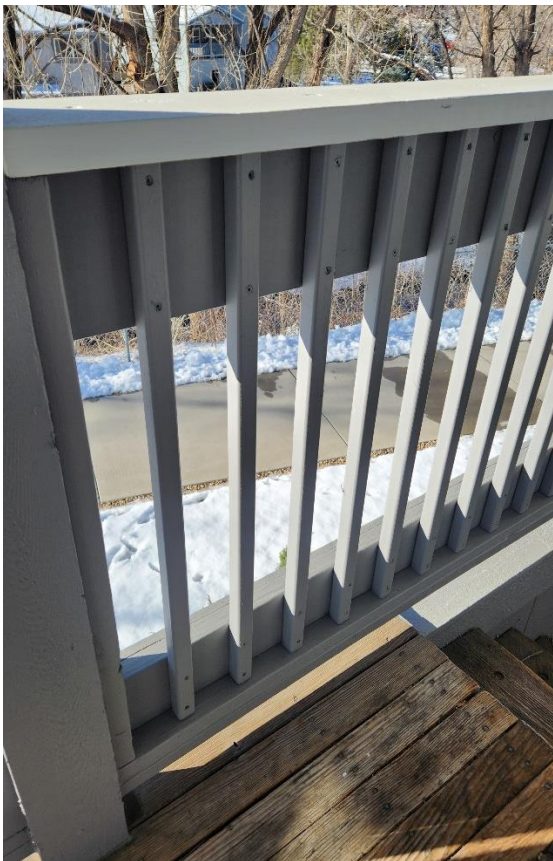
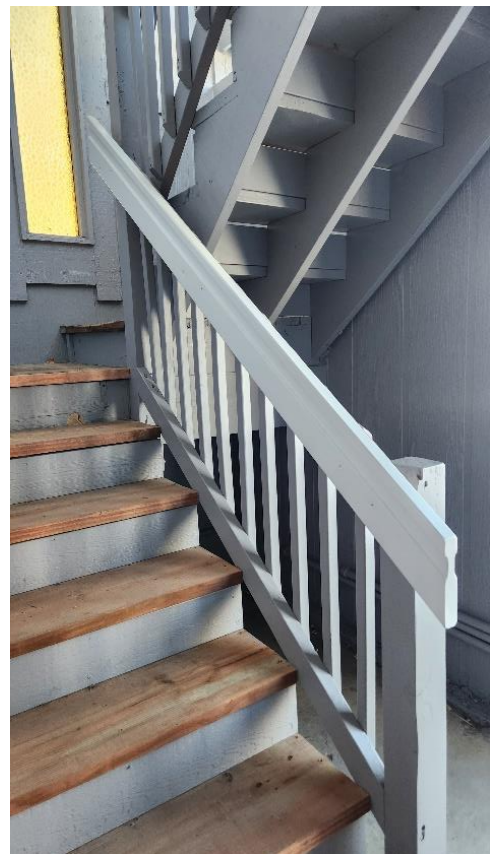
D Unit Repairs: As buildings are identified for repair, the stairs, stair railings, and balcony railings are evaluated, prioritized, and contracted for separately, depending on budget availability. The original open stairs with only two stringers, metal stair railings with balusters too far apart, and the wood balcony railings do not meet current codes. Photos below of rotten balcony railing, new balcony railing design which prevents wasp's nests, and new stairs with closed risers, three stringers, balusters the proper distance apart, and proper handrail.
