Park East Square HOA
Boulder, CO

Report #: 31350-1
Beginning: January 1, 2025
Expires: December 31, 2025

RESERVE STUDY
Update "With-Site-Visit"

March 28, 2025

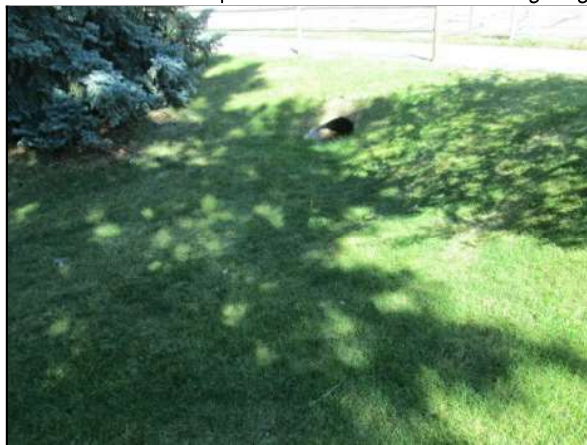
**Best Case:** \$ 18,000**Worst Case:** \$ 24,000**Cost Source:** ARI Cost Database: Similar Project Cost History**Comp #: 25771 Irrigation Lines - Inspect****Quantity: (1) System****Location:** Common areas**Funded?:** No. Does not meet National Reserve Study Standards - not predictable**History:****Comments:** Unfunded component included at the request of the client for future budgeting purposes.**Useful Life:****Remaining Life:**

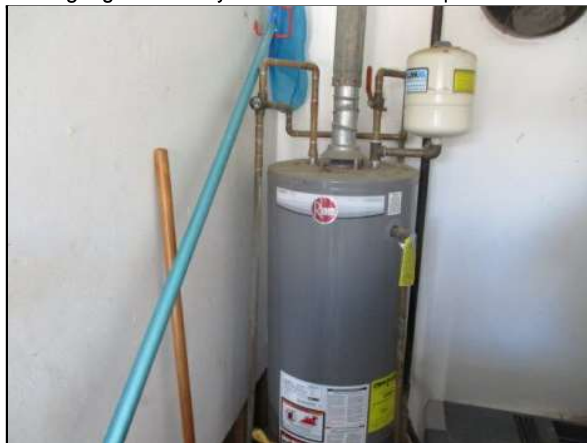
Comp #: 25460 Water Heater/Tank - Replace

Comments: Includes (1) Rheem 34,000 BTU, 40 Gallon Water Heater (M: PROG40-38N RH62H, S: M181605852). Minimal or no subjective/aesthetic value for this component. Useful life is based primarily on normal expectations for service/performance life in this location. Unless otherwise noted, remaining useful life expectancy is based primarily on original installation or last replacement/purchase date, our experience with similar systems/components, and assuming normal amount of usage and good preventive maintenance. Water heater life expectancies can vary greatly depending on level of use, type of technology, amount of preventive maintenance and other factors. Should be inspected and repaired as needed by servicing vendor or maintenance staff. Unless otherwise noted, expected to be functional. Plan to replace at the approximate interval shown below. When evaluating replacements, we recommend choosing high-efficiency or tankless models if possible in order to minimize energy usage.

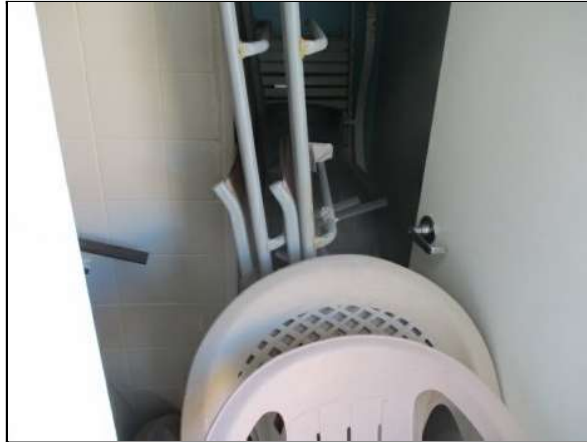
Comp #: 28040 Pool Furniture - Replace

Comments: Includes (31) chairs, (5) tables, (2) umbrellas, (9) lounges, and (7) drink tables. The furniture appeared in generally poor condition. Furniture and decor appeared to be older and outdated. Plan to update soon. We recommend regular inspections and repair or replacement of any damaged pieces promptly to ensure safety. Protected storage of furniture when not in use can help to extend useful life. Best practice is to replace all pieces together in order to maintain consistent style and quality in the pool/recreation area. Costs can vary greatly based on type of pieces selected for replacement. Funding recommendation shown here is based on replacement with comparable number and quality of pieces.

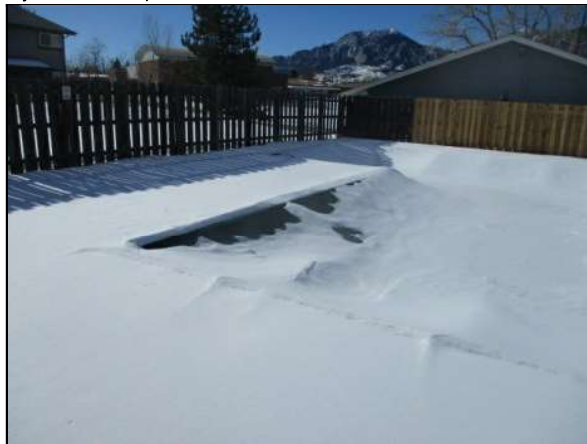
Comp #: 28050 Deck - Repair - 10%

Comments: Decking was reported to be in fair condition. Deck was not exhibiting major signs of wear and/or age. Pool decks may be exposed to harsh chemicals that can leave stains if not addressed properly. Periodic pressure-washing and repairing will restore the appearance and prolong the need for major restoration or replacement of the deck surface. Take note of any places where water is ponding, which may result in slip-and-fall hazards if not corrected.

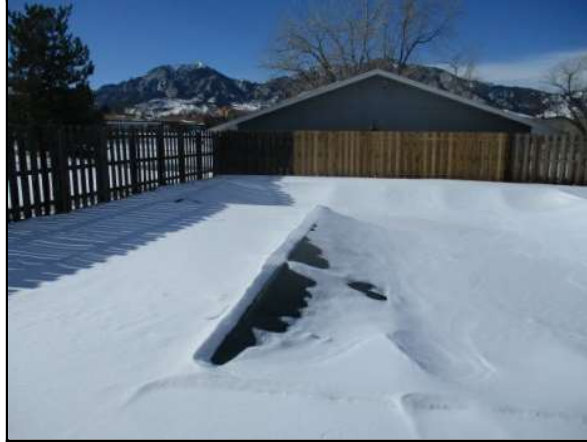
Comp #: 28090 Coping Stones - Repair

Comments: Pool surfaces with similar relative age tend to be in poor condition. Unable to observe Pool surfaces during Site Inspection. Client reported no recent work on pool surfaces. Coping stones with similar relative age tend to be in poor condition. The concrete surfaces tend to exhibit hairline cracking, shrinkage, and settlement cracking. These issues can result in water entry to the base, which can ultimately lead to trip hazards. Exposure to sunlight, weather, and pool chemicals can lead to larger, more frequent repairs, especially for older properties. Inspect all areas periodically to identify trip hazards or other safety issues. Timeline and cost ranges shown here should be re-evaluated during future Reserve Study updates.

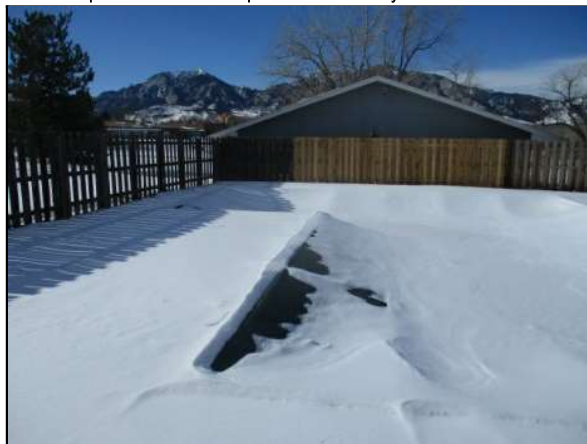
Comments: Pool surfaces with similar relative age tend to be in poor condition. Unable to observe Pool surfaces during Site Inspection. Client reported no recent work on pool surfaces. Small repairs to waterline tile should be done as needed as an Operating expense. Complete re-tiling is warranted at longer intervals to restore the look and feel of the interior finish. While drained for resurfacing, any other repairs to lighting, handrails, stairs, ladders, etc. should be conducted as needed. This type of project is best suited for slow/offseason to minimize downtime during periods when pool is used heavily. Should be expected at the approximate interval shown below to preserve this important amenity of the client.

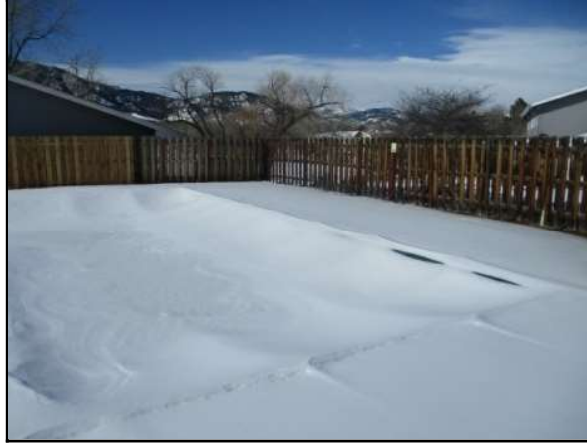
Comments: Pool surfaces with similar relative age tend to be in poor condition. Unable to observe Pool surfaces during Site Inspection. Client reported no recent work on pool surfaces. Pool surfaces with similar relative age exhibit considerable pitting, chipping, un-even, and broken surfaces. Cracks were observed to be substantial. Approximately 1018 GSF footprint area with 146' waterline/perimeter length. Pool resurfacing will restore the aesthetic quality of the pool while protecting the actual concrete shell of the pool from deterioration. While drained for resurfacing, any other repairs to lighting, handrails, stairs, ladders, etc. should be conducted as needed. This type of project is best suited for slow/offseason to minimize downtime during periods when pool is used heavily. Should be expected at the approximate interval shown below in some cases, schedule may need to be accelerated due to improper chemical balances or aesthetic preferences of the client.

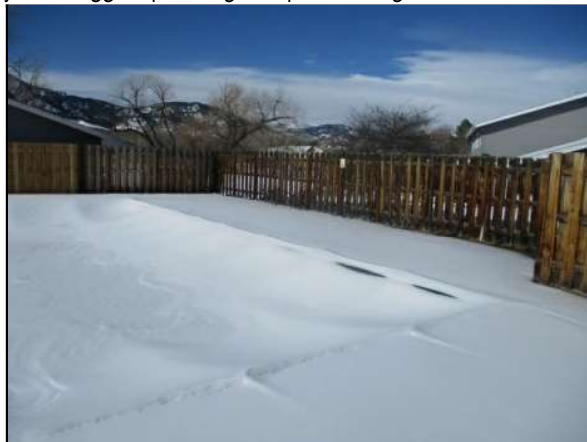
Comp #: 28140 Pool Cover - Replace

Comments: Cover was reported to be in fair condition. Fabric was noted to be in fair condition with no major ripping observed. Inspect regularly and properly store when not in use. Cover can provide cost savings for temperature differentials, reduce cleaning costs and provide safety. We suggest planning to replace at regular intervals to maintain proper functionality.

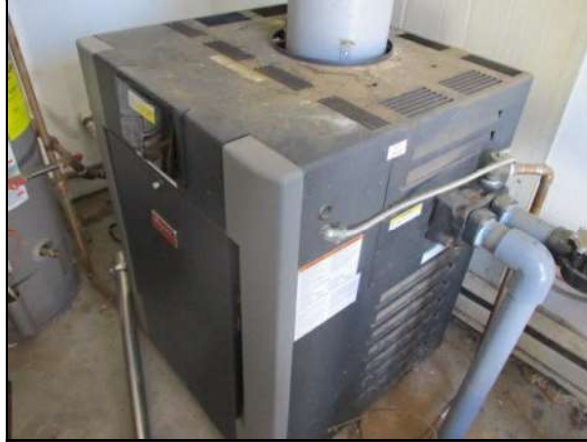
Comp #: 28170 Pool Heater - Replace

Comments: Includes (1) Raypak 399,000 BTU Pool Boiler (M: C-R406A-EN-C ASME, S: 1801458034). Pool vendor should inspect heater regularly to ensure proper function, identify any required repairs, etc. Internal components were not analyzed during our site inspection. Many clients choose not to heat their pools year-round, which can prolong the life of the heater while reducing energy costs. When replacement models are being evaluated, we recommend considering high efficiency models which may have a higher initial cost but will ultimately be less expensive due to reduced energy usage.

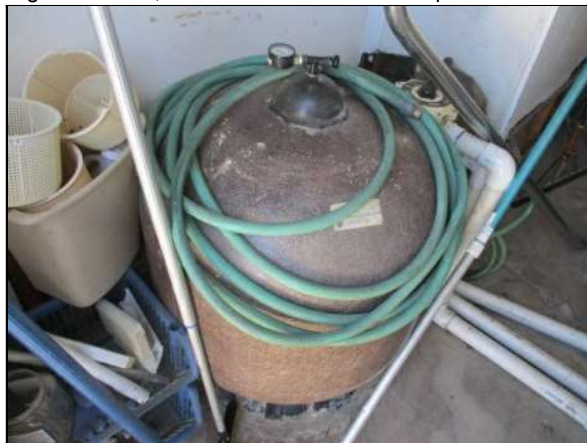
Comp #: 28190 Pool Filter - Replace

Comments: There is one (1) Triton TR-100 on the property. It was installed in 2004 and was in overall good condition at the time of inspection. Pool vendor should inspect regularly for optimal performance and address any repairs or preventive maintenance as needed. Life can vary depending on location, as well as level of use and preventive maintenance.
