**Background:** After many years of minimal repairs, in order to protect our owner's assets, the HOA has now spent 8+ years repairing the siding and trim on approximately 6 buildings per year, using two different companies. This document aims to consolidate the knowledge and lessons learned and create some "performance specifications" or requirements for future work.

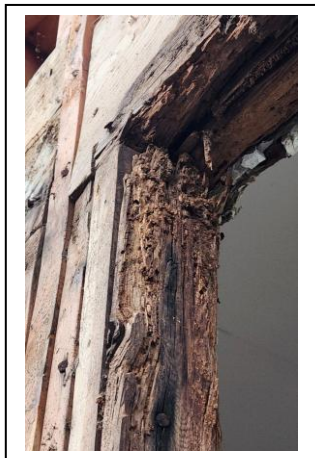
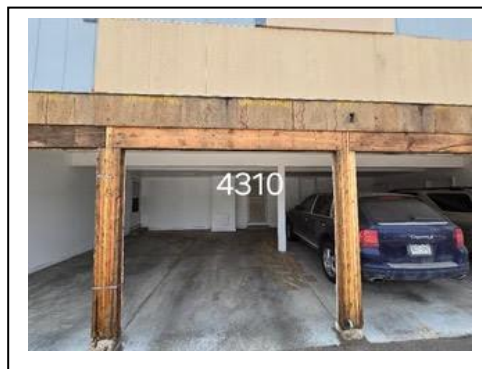
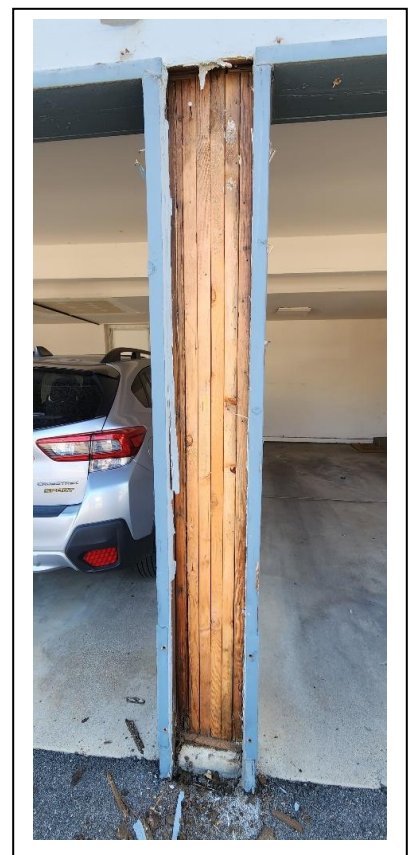
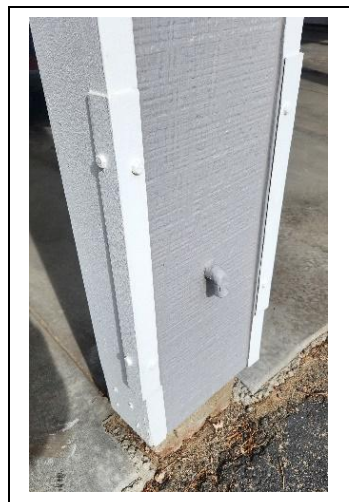
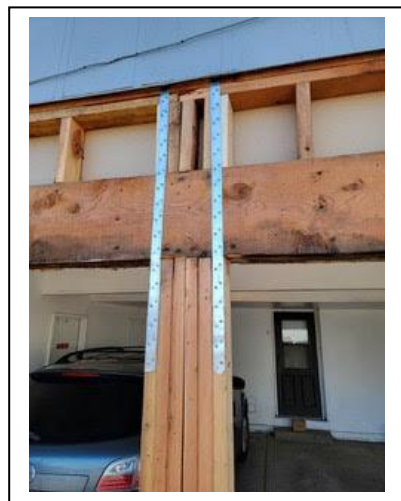
- Repairs are begun by removing the carport trim boards, some of the siding above the carport opening, and on the carport posts to check and ensure the structural integrity of the posts and headers. Typically there is one header over each carport opening. Occasionally the carport headers are discovered to be rotten, but more often the headers are still structurally sound with only a few checks (cracks) and moisture staining. Occasionally we discover anomalies in the “standard” building construction – see photo of carport header that spans two carport openings. In this case, the header was bowing outwards a bit and required inspection by a structural engineer, who provided instructions on how to correct the bowing with metal straps.

- The “celotex” material underneath the siding is only removed when it is swollen, rotting, or warped. The posts consist of king studs in the center which support the second story rim joist, and studs that support the carport headers, which also indirectly support the second story rim joist. As a rule, the posts generally aren’t structurally compromised, but if they are, the studs are easily replaced.

- New carport opening trim boards (2 x 6’s) are re-installed to be flush with the siding and trim, and the trim is flashed to prevent future moisture intrusion. Metal L-brackets (often salvaged from the old trim boards) are attached to the 2 x 6’s at car bumper height for reinforcement.

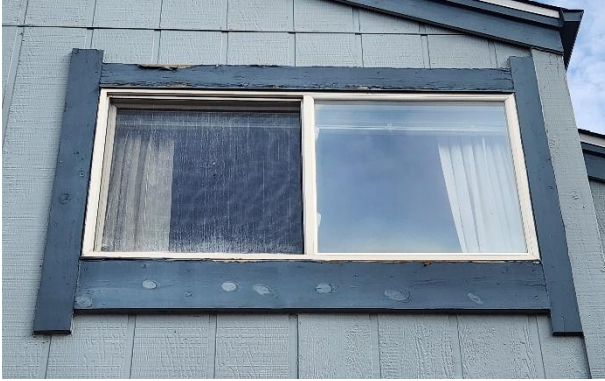
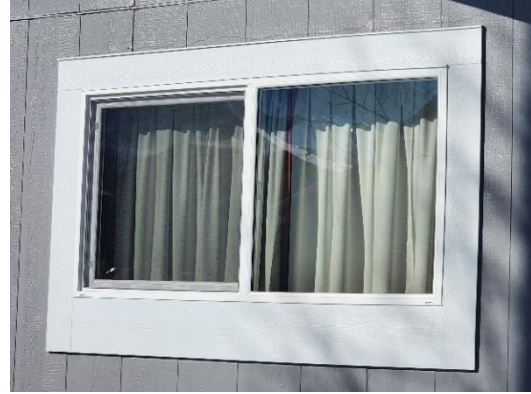
- All windows and trim are checked for moisture intrusion. The original trim designs (with vertical or horizontal “tabs”) should be corrected to deter moisture intrusion, either by replacing the trim if rotten, or removing the water-catching pieces if the trim is in good shape. When trim is replaced, the top piece should extend all the way across (and be flashed), the bottom piece should be just under the window, and the side pieces should extend to the bottom of the bottom trim. See photo with white trim below.

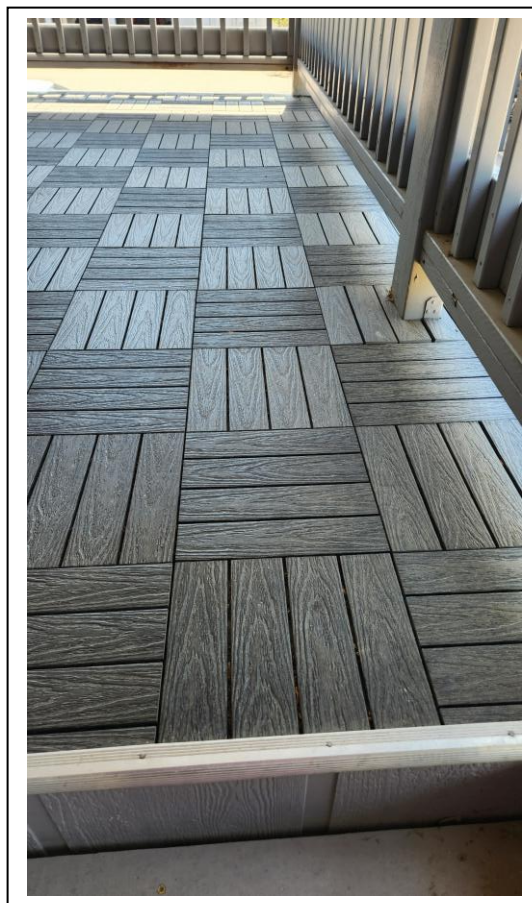
Although the HOA hasn't yet had the funds to begin replacing D Unit decks, we experimented with a new decking system after the fire at building 4232. This new system which includes a new membrane over the trash room to prevent moisture from damaging the trash room ceiling, new stringers to support the decking, and new modular decking as shown in the photo.

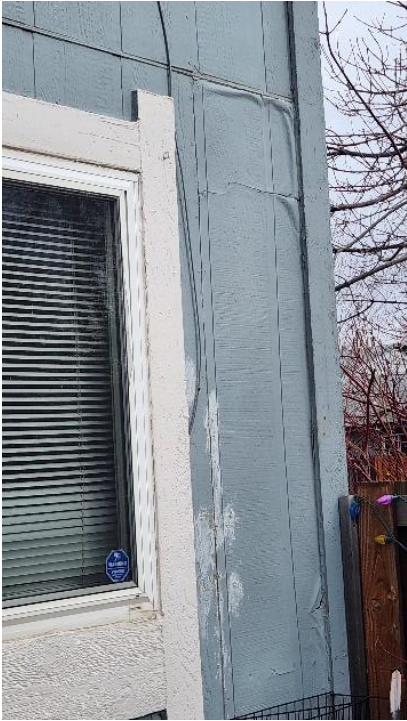
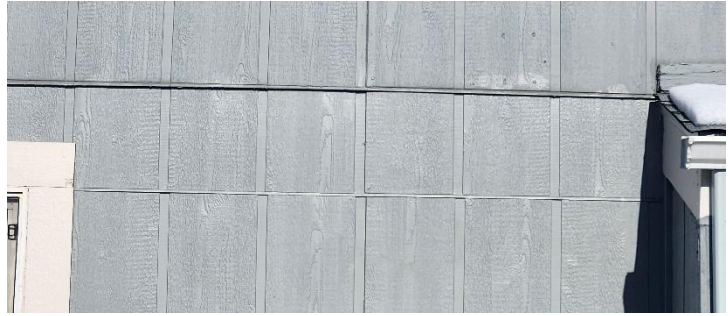
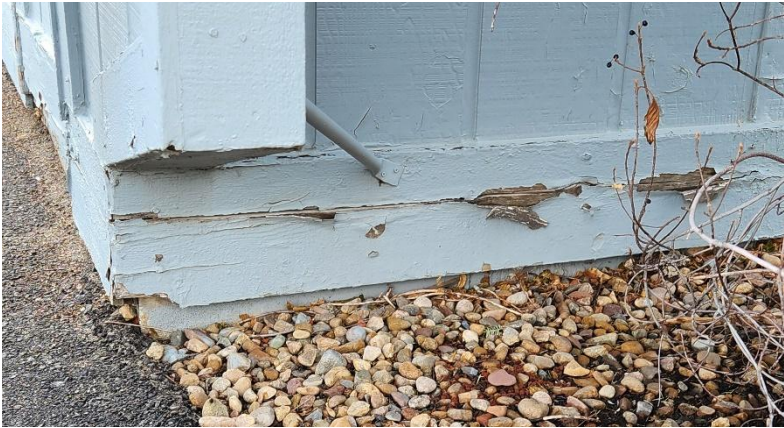
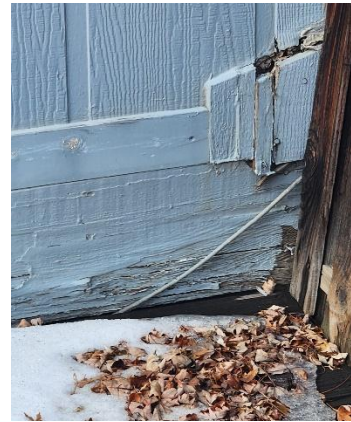
- Buckled or rotten siding due to sun or moisture is replaced. The wall of the B unit next to the A unit is frequently rotten. Unfortunately, the original building used 9 foot sheets of siding, and only 8 foot sheets are now available. So some horizontal joints (see photo below) are now required with proper flashing. OSB is used to replace rotten cellotex. Then Tyvek building wrap is installed under all new siding.

- Trim boards near the ground are often replaced and flashed due to being rotten, with Tyvek house wrap underneath. It's important to pull soil and rock away from the trim boards.

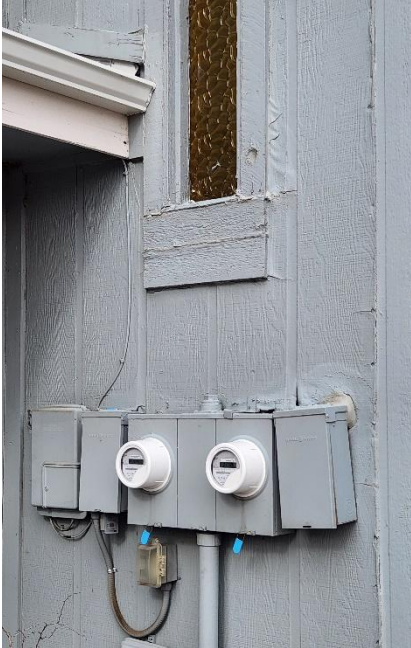
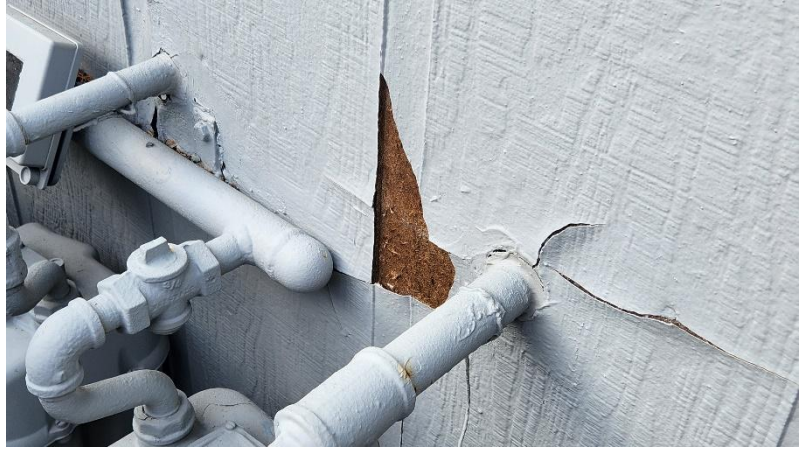
- Meter wall siding exposed to the elements (outside of D unit stairs, and A units) are occasionally rotten. We call Couper Electric to disassemble the electricity for a few hours while we replace the siding and reattach the utility boxes. Gas must be handled with Xcel.

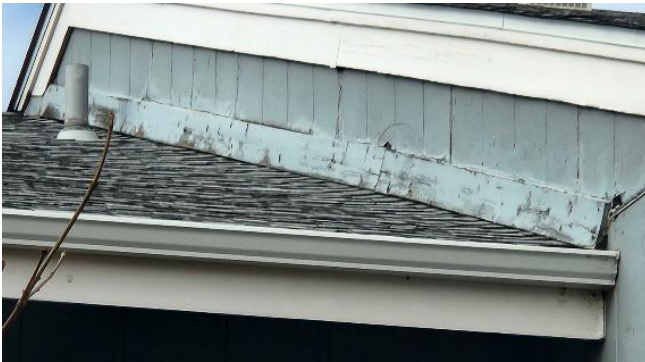
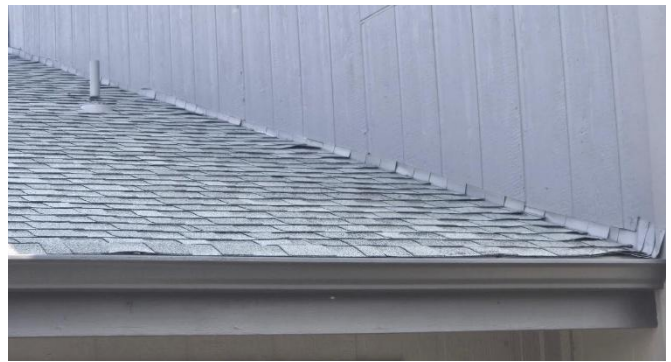
- Inspect roofs for missing shingles, improper step/rake flashing installation, and missing gutter apron or improper pitch of gutters. Where the unit siding abuts adjacent roofs, proper flashing is sometimes needed, and old, ineffective trim boards are removed. Siding should be at least 1.25 inches above the roofline to prevent siding from wicking moisture up the wall. The same holds true for the small decorative roofs over A and C unit front doors and sliding doors. If stovepipes are no longer in use, Owners are encouraged to pay for their removal and restoration of the roof.
